# Manhole Inspection Summary

Manhole # S19M\_\_025MH

Insp Date: **3/24/08 8:26 AM**

**Location** Address: **348 s payson st**

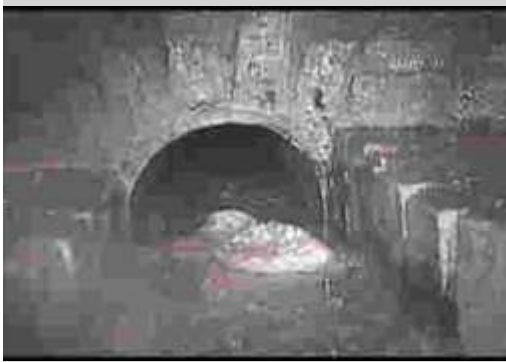
Defect

Condition: ☐ Sound ☐ Cracked ☐ Root Intrusion ☐ Deteriorated ☐ Leaks ☒ **Debris**

channel cond debris

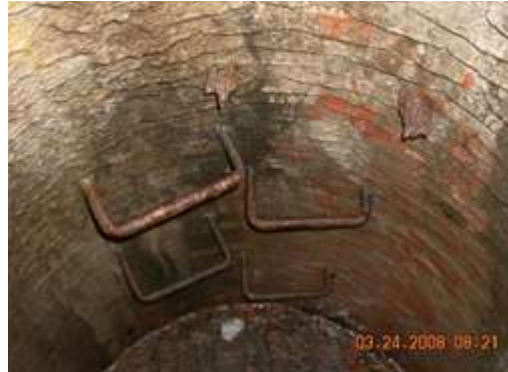
Defect 5

**Steps** Count: **4** Missing: **1** ☒ **Corroded**

corroded and missing steps

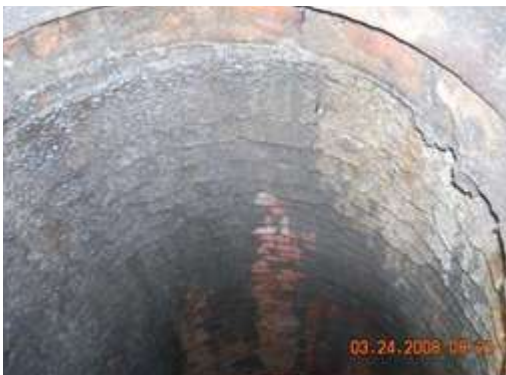
Defect 4

Infiltration: ☐ None ☒ **Joint** ☐ Cracks ☐ Mortar ☐ Roots ☐ Wall

infiltration @ chimney joint

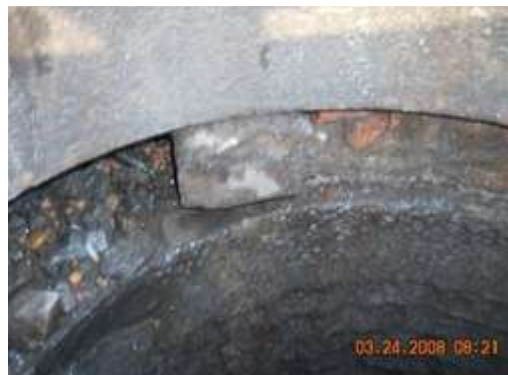
Defect 3

loose chimney brick

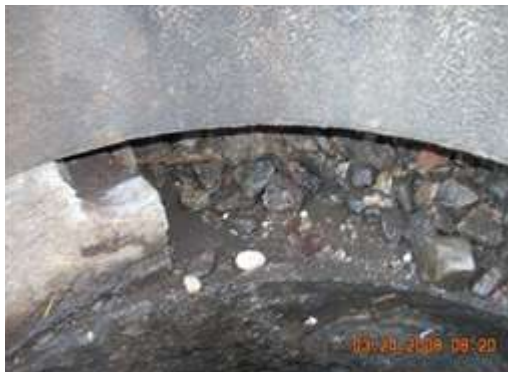
Defect 2

deteriorated chimney

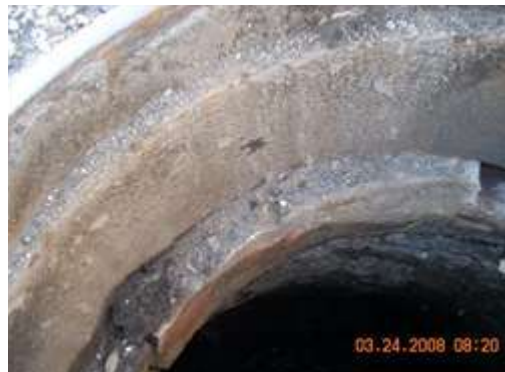
Defect 1

**Frame** Offset: **2** (in.) Condition: ☒ Sound ☐ Cracked ☐ Leaks

frame offset

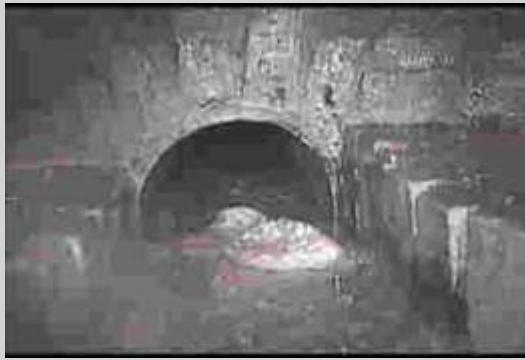
12 O'Clock Outflow

8 in. Circular Gravity Sewer  
Pipe Out @ 12 O'Clock

Pipe Height: **8.4** (in.) Rod and Bar (Angled)  
Pipe Material: **Clay** ☐ Pipe Lined  
Invert Depth: **9.76** (ft.) Flow Characteristics: **Slow**  
Deposits: ☐ None ☐ Mud ☒ **Sludge** ☐ Debris ☐ Grease  
Silt Depth: **3** (in.) Deposits Extent: **Medium**  
Infiltration: **None** Pipe Seal Cond: **Sound**

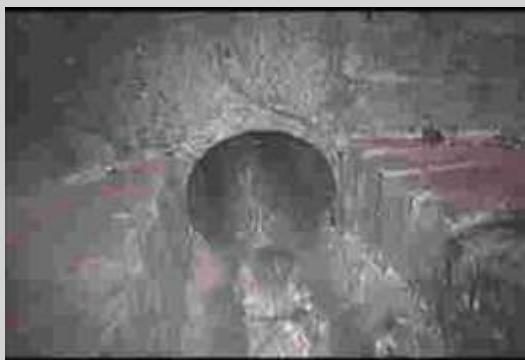
4 O'Clock Inflow

6 in. Circular Gravity Sewer  
Pipe In @ 4 O'Clock

Pipe Height: **6** (in.) Rod and Bar (Angled)  
Pipe Material: **Clay** ☐ Pipe Lined  
Invert Depth: **9.28** (ft.) Flow Characteristics: **Slow**  
Deposits: ☒ None ☐ Mud ☐ Sludge ☐ Debris ☐ Grease  
Silt Depth: **0** (in.) Deposits Extent:  
Infiltration: **None** Pipe Seal Cond: **Sound**

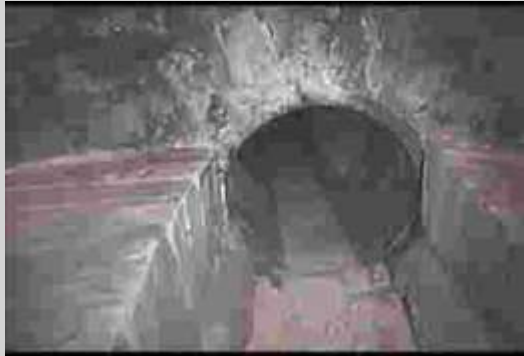
7 O'Clock Inflow

8 in. Circular Gravity Sewer

Pipe In @ 7 O'Clock

Pipe Height: **8.4** (in.) Rod and Bar (Angled)

Pipe Material: **Clay** ☐ Pipe Lined

Invert Depth: **9.50** (ft.) Flow Characteristics: **Slow**

Deposits: ☒ None ☐ Mud ☐ Sludge ☐ Debris ☐ Grease

Infiltration: **None** Pipe Seal Cond: **Sound**
